29. Site 29 at RM 339.3 LDB (Pool 21)

30. Site 30 at RM 339.3 RDB (Pool 21)

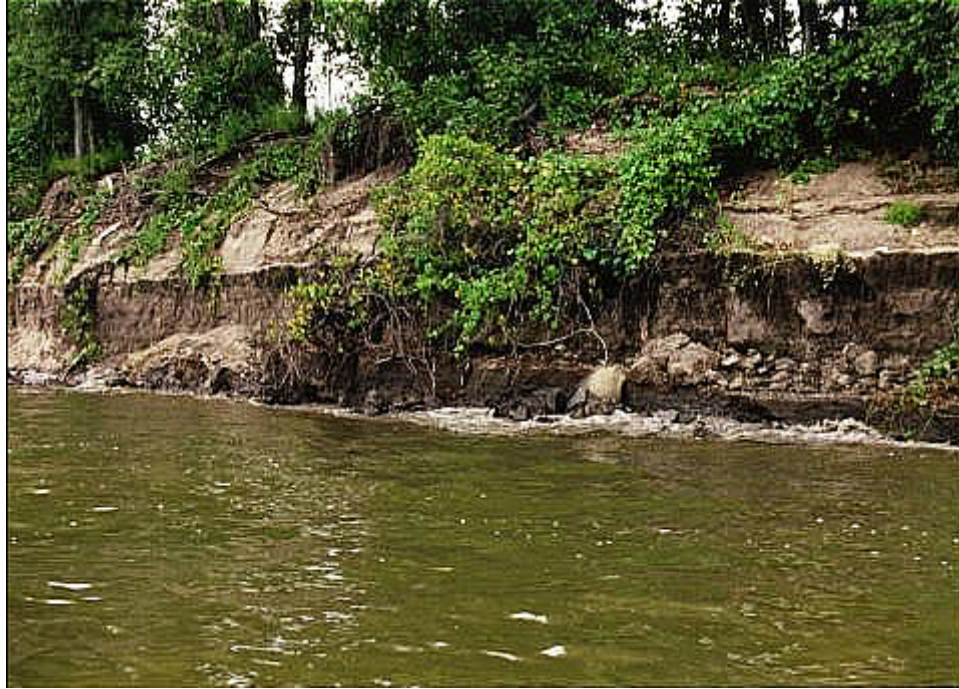
Causative factors for bank retreat at this site include piping, flood-flow erosional oversteepening and rapid recession and piping-initiated failures, block failures, and wave and flow rework-transport of failed soils and recently deposited sediments within bench areas. This site is characterized by a combination of Types A, B, and C.

Photo 7-65 An upstream view of Site 29 midpoint

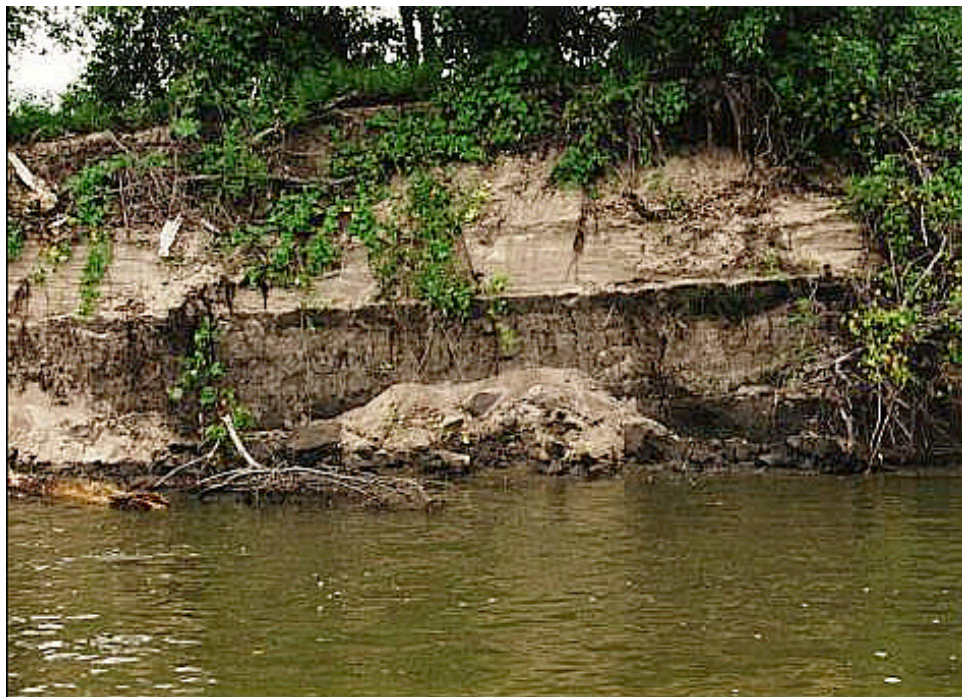
Photo 7-66 A perpendicular view of Site 29 midpoint

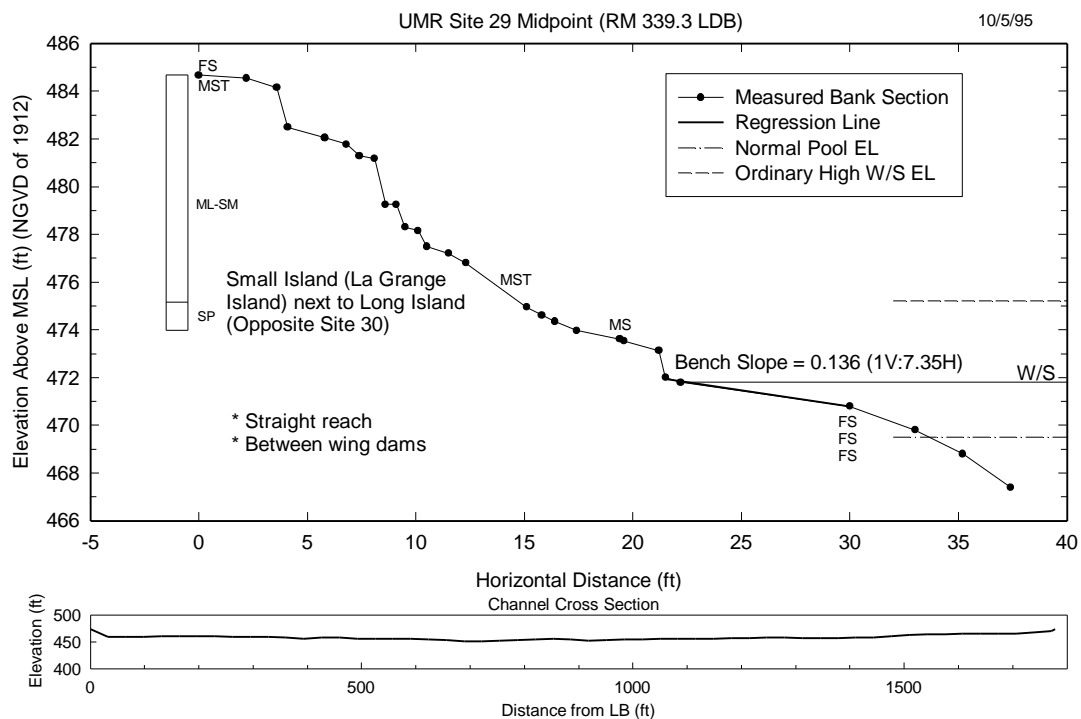
Figure 7-103 Bank section and channel cross section measured at Site 29 midpoint

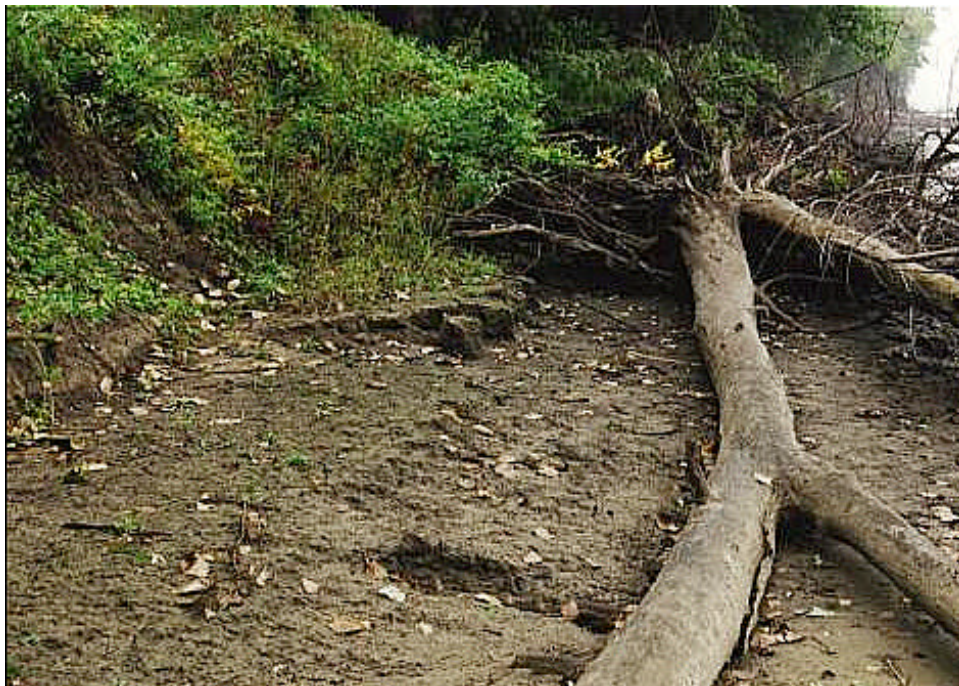
Photo 7-67 An upstream view of Site 30 midpoint

Causative factors for bank retreat at this site include flood-flow erosional oversteepening and rapid recession and piping-initiated failures, and wave and rework-transport of failed soils and recently deposited sediments within bench areas. Secondary wave erosion occurs within berm and bench areas. The bank is classified as Type C.

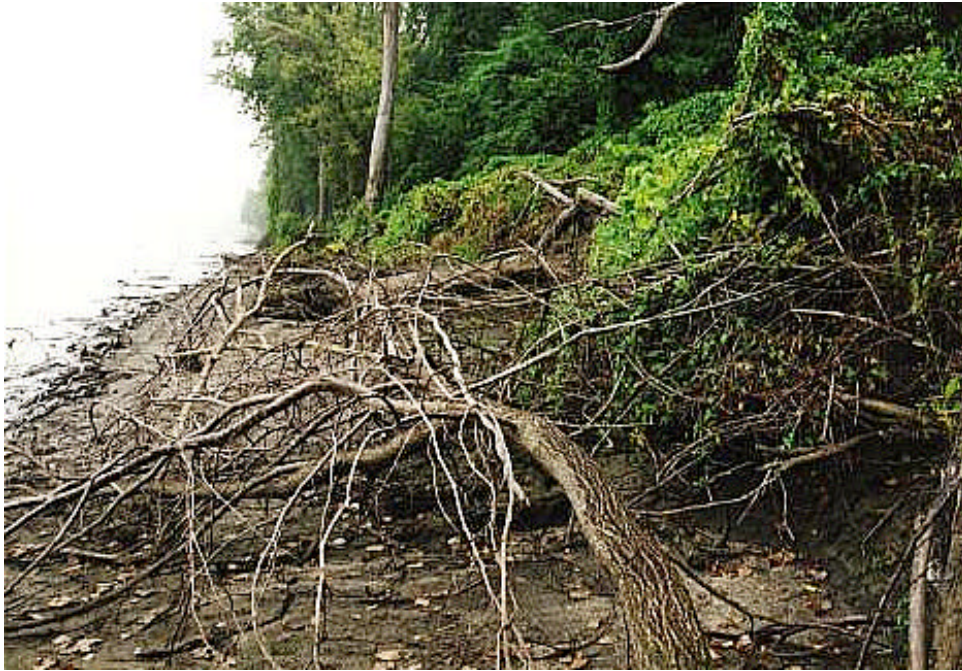
Photo 7-68 A downstream view of Site 30 midpoint

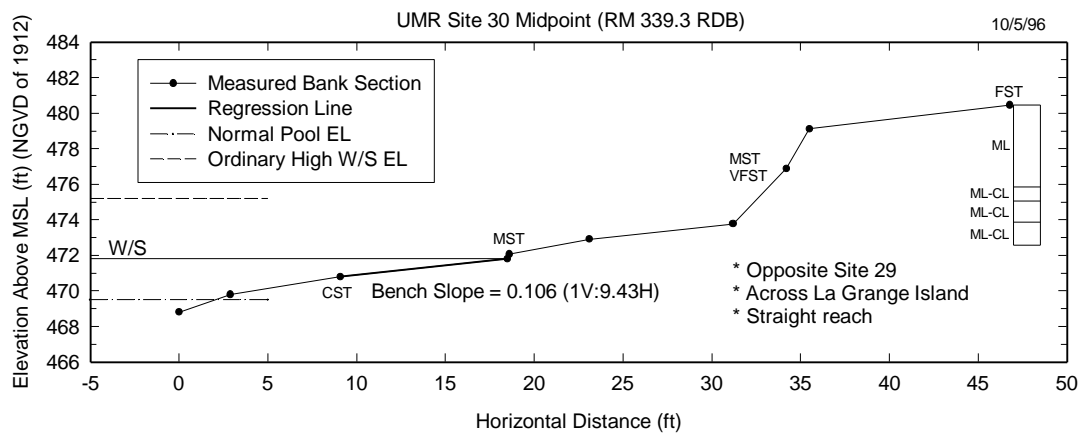
This right-bank site is located opposite Site 29. Photos 7-67 and 7-68 show upstream and downstream views of the site. Only one bank section was taken at this site, as shown in figure 7-105. The scarp is almost 6 ft high. The bank soils are silts (VFST-MST) and subaqueous soil is CST.

Figure 7-105 Bank section measured at Site 30 midpoint

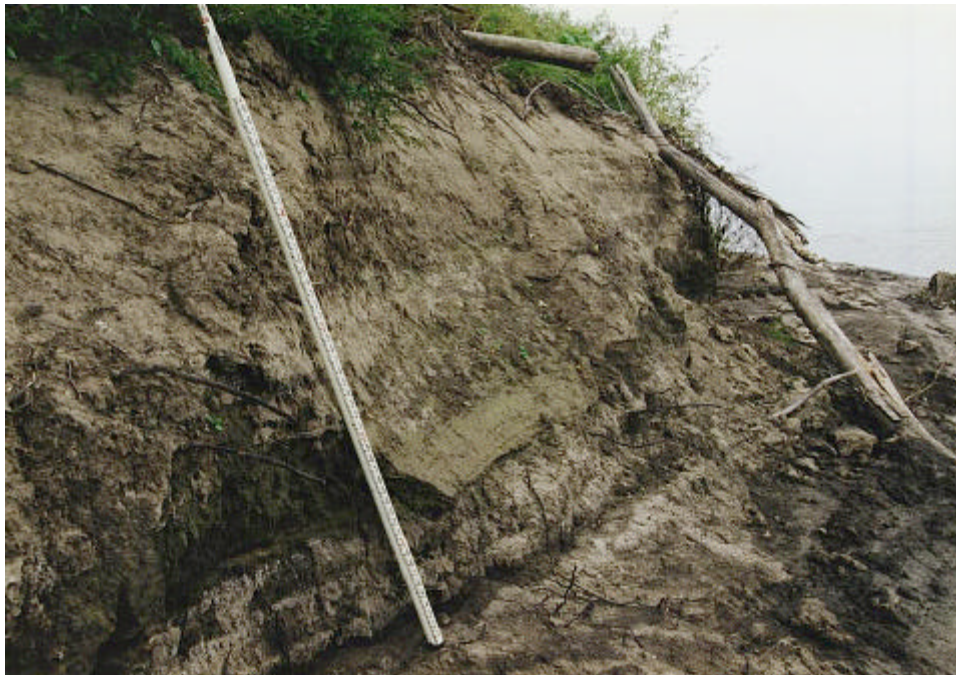
Photo 7-69 Bank soil scraped by a barge - Observation Site at RM 322.9 RDB

Causative factors for bank retreat at this site include flood-flow erosion, rapid recession and piping-initiated block failures, barge-mooring impacts, and wave and flow rework-transport of failed soils and recently deposited sediments which cover bench areas. Type A characteristics describe this observation site.

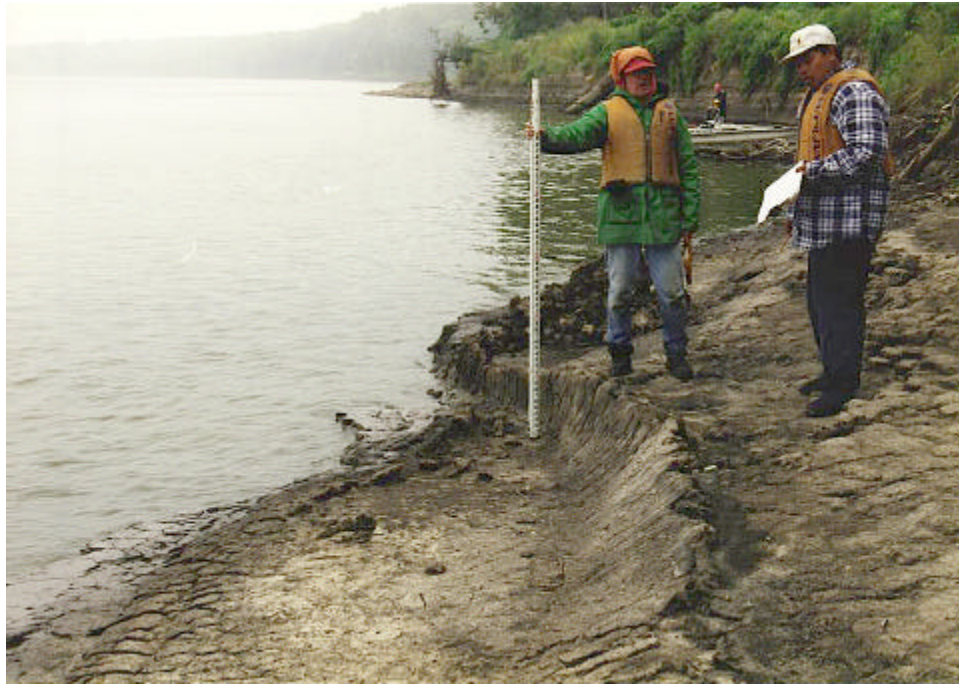
Photo 7-70 Bench smeared by a barge - Observation Site at RM 322.9 RDB

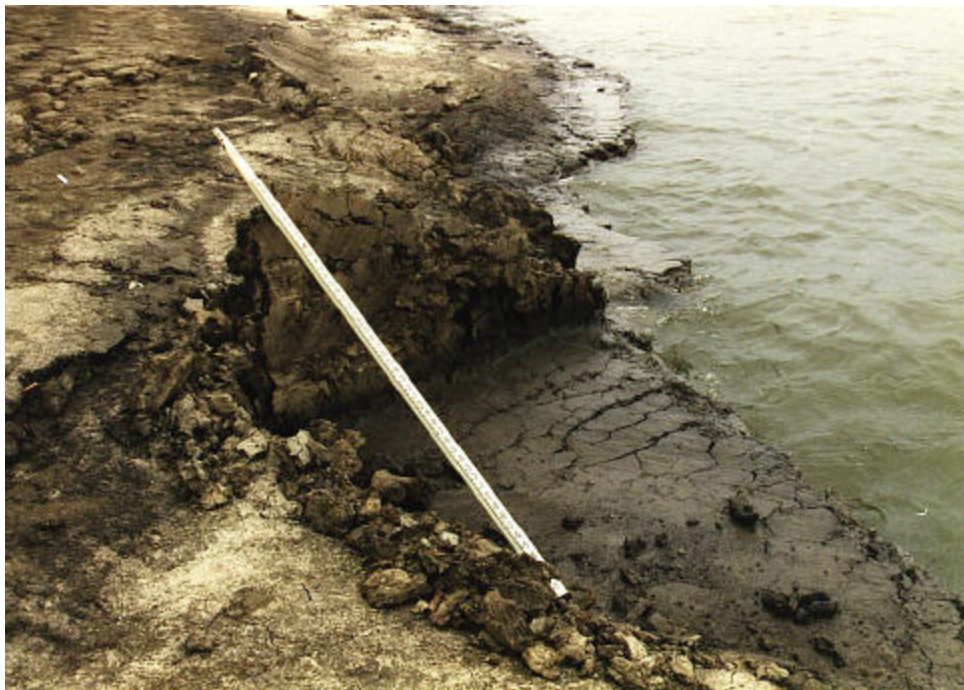
Photo 7-71 Close-up of smeared bench - Observation Site at RM 322.9 RDB

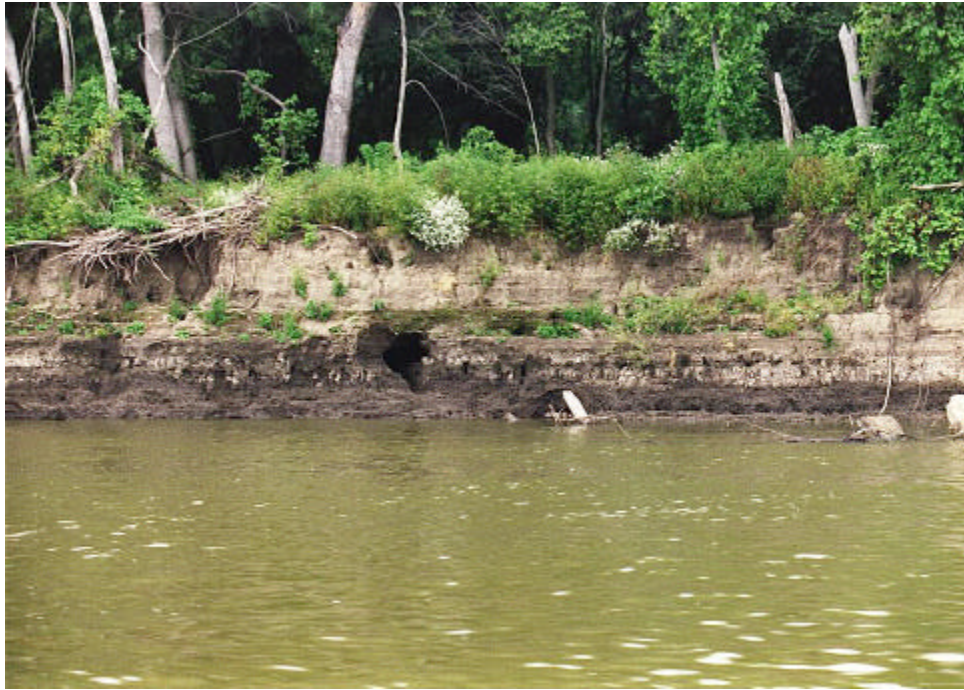
Photo 7-72 Piping features - Observation Site at RM 322.9 RDB

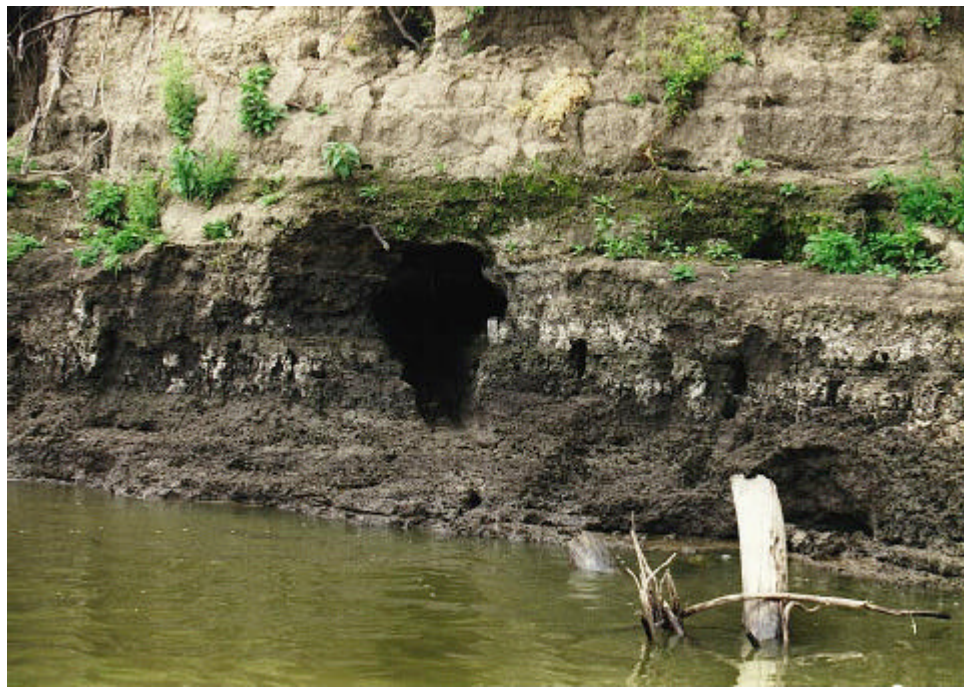
Photo 7-73 Close-up of piping features - Observation Site at RM 322.9 RDB

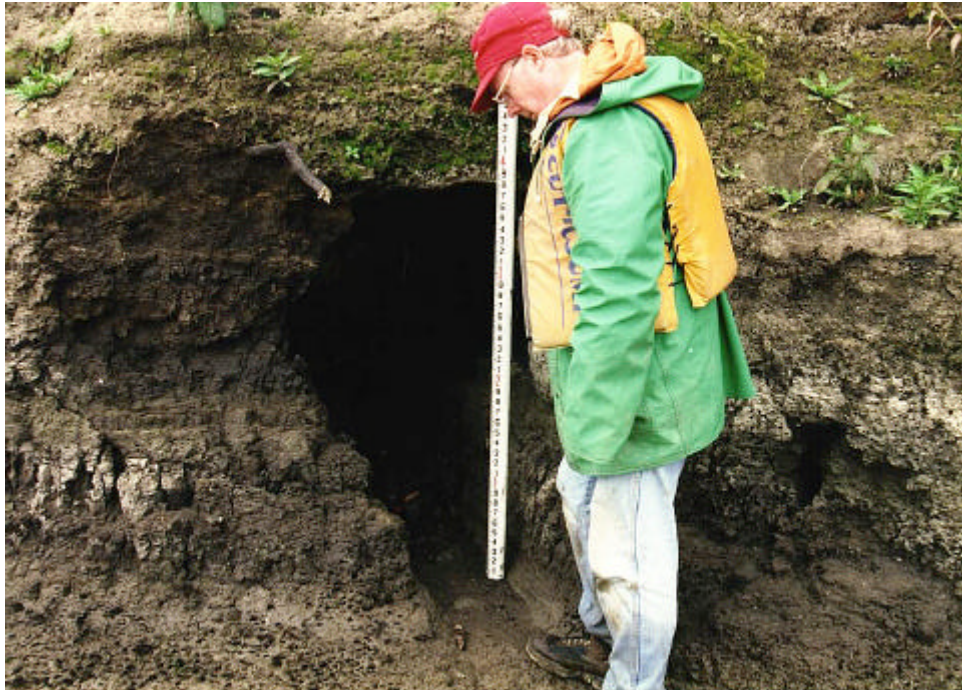
Photo 7-74 Further close-up of piping features - Observation Site at RM 322.9 RDB

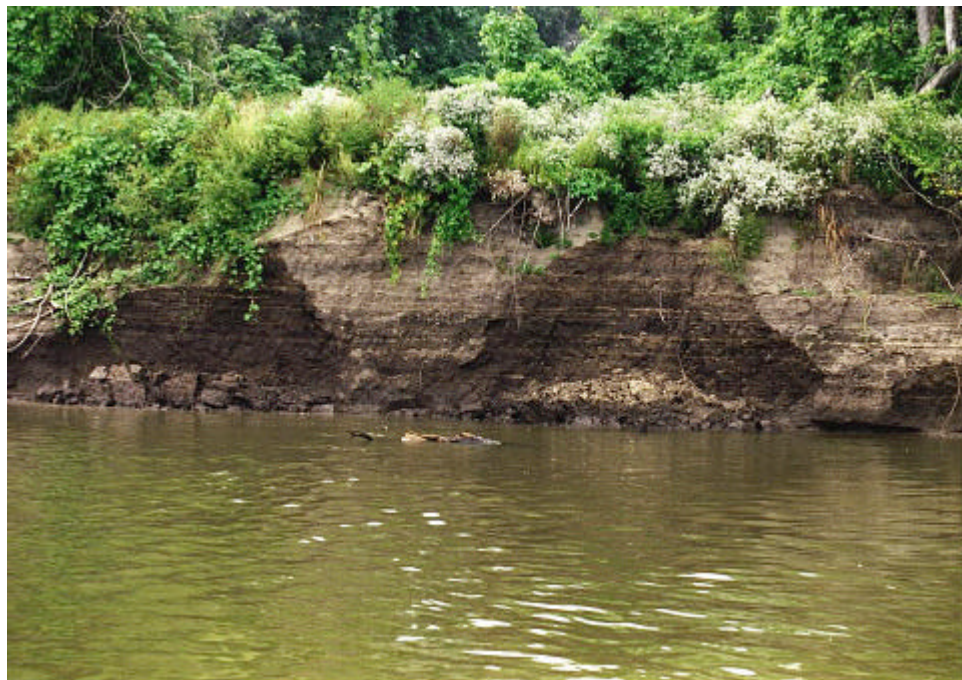
Photo 7-75 Vertical bank failure - Observation Site at RM 322.9 RDB

pipng features. Neither bank sections nor soil samples were taken at this observation site. However, visual observations indicated that the upper scarp consisted of ML (see table 7-4) and the lower scarp consisted of two layers of soils (CH on top of SM).

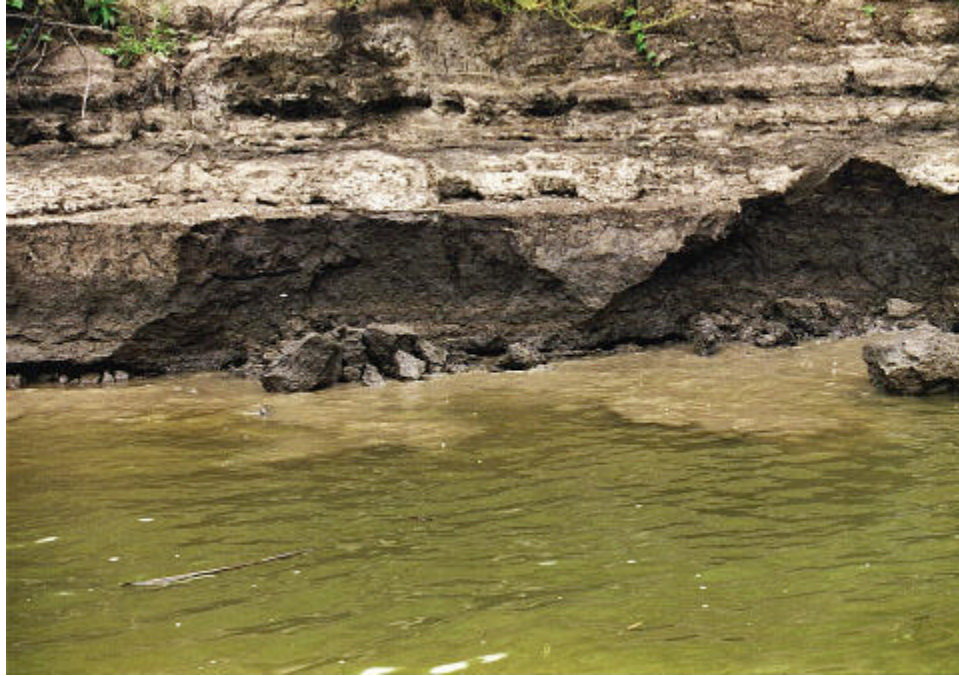
Photo 7-76 Vertical failure of lower bank - Observation Site at RM 322.9 RDB

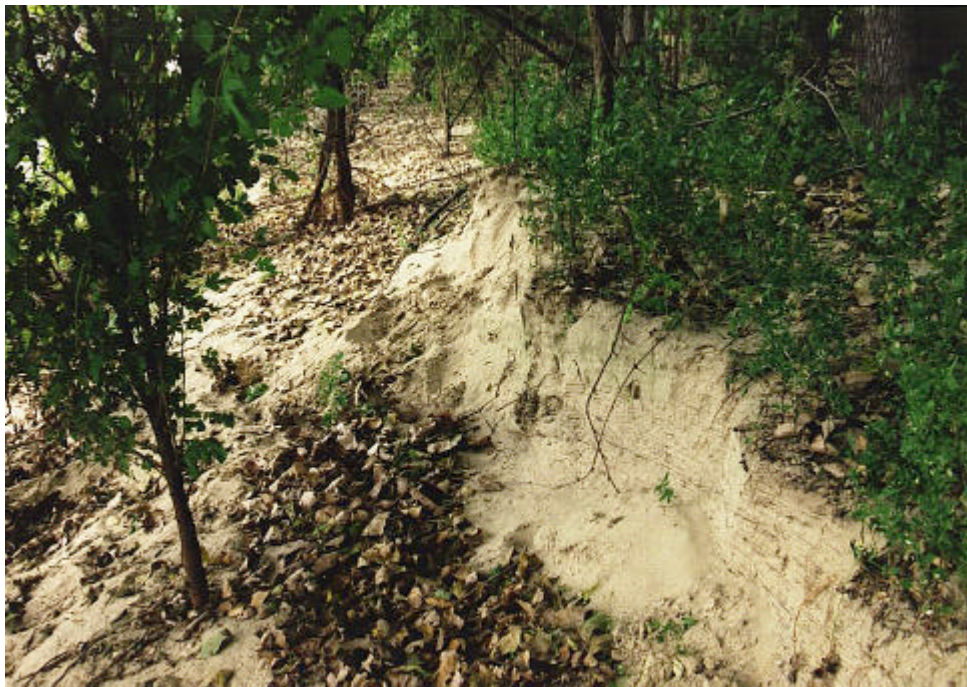
with some medium silt (MST). Denmark Island is covered with sand deposit from the Great Flood of '93. No geomorphic soil core samples were taken at Site 31.

Photo 7-78 Sand deposits on Denmark Island of Site 31 midpoint

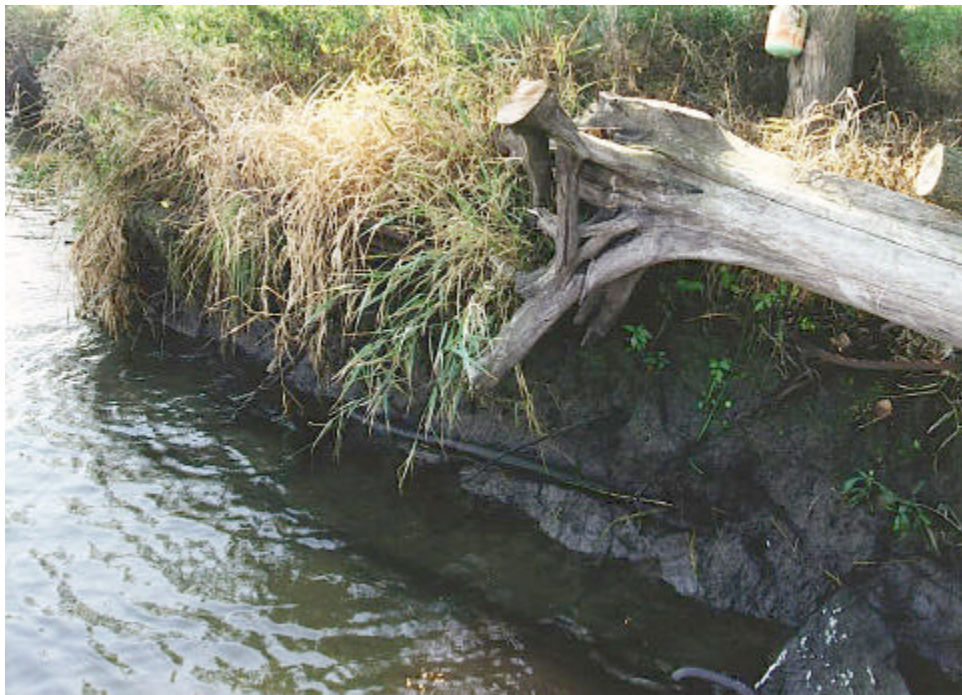
Photo 7-80 A close-up view of mooring activities at Site 32 midpoint

Causative factors for bank retreat at this site include flood-flow erosional oversteepening and subsequent failures, bench-area rework-transport of failed soils and recently deposited sediments by waves, and barge-mooring activities. Evidence of erosion due to traffic-generated waves and turbulence, and barge mooring exists at this site. Type A is the most representative classification for Site 32.

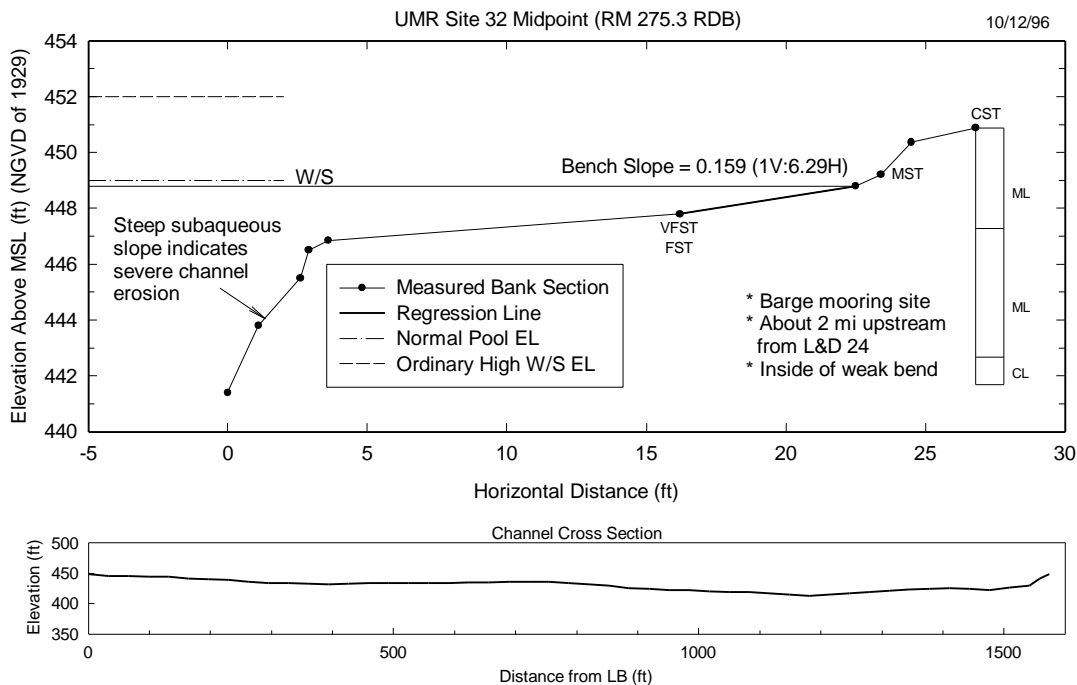
This right-bank inside-bend site, shown in figure 7-108, is located in a mooring zone, only 2 miles upstream from Lock & Dam No. 24. Photo 7-79 shows a downstream view of the site, and Photo 7-80 shows a close-up view of the bank disturbed by mooring activities. Note the sign on the tree shown in Photo 7-79. Only one bank section was taken at this site, which is shown in figure 7-109. The bank material is silt (CLT-MST). Subaqueous soil is primarily silt (VFST-FST). This site is used heavily as a barge-mooring site where tow boats wait for downstream locking at Lock & Dam No. 24. Although this erosion site is located along the inner bank, the river cross section in figures 7-109 indicates that the thalweg is developing along the right bank. Evidence of severe in-

channel flood-flow erosional oversteepening is visible in the bank-section defined topographic features.

Figure 7-109 Bank section and channel cross section measured at Site 32 midpoint

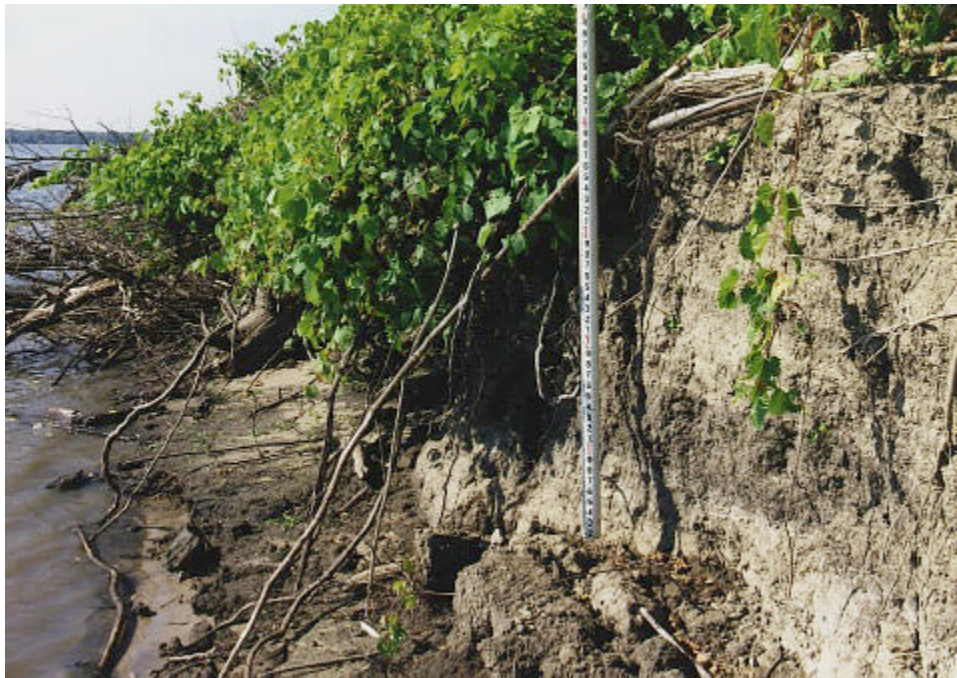
One bank section taken at the midpoint is shown in figure 7-111. The bank soils are primarily silt (VFST-CST). The scarp is almost vertical and contains numerous piping features. Failed soil blocks had accumulated at the toe of the scarp.

Photo 7-82 A close-up view of Site 33 midpoint

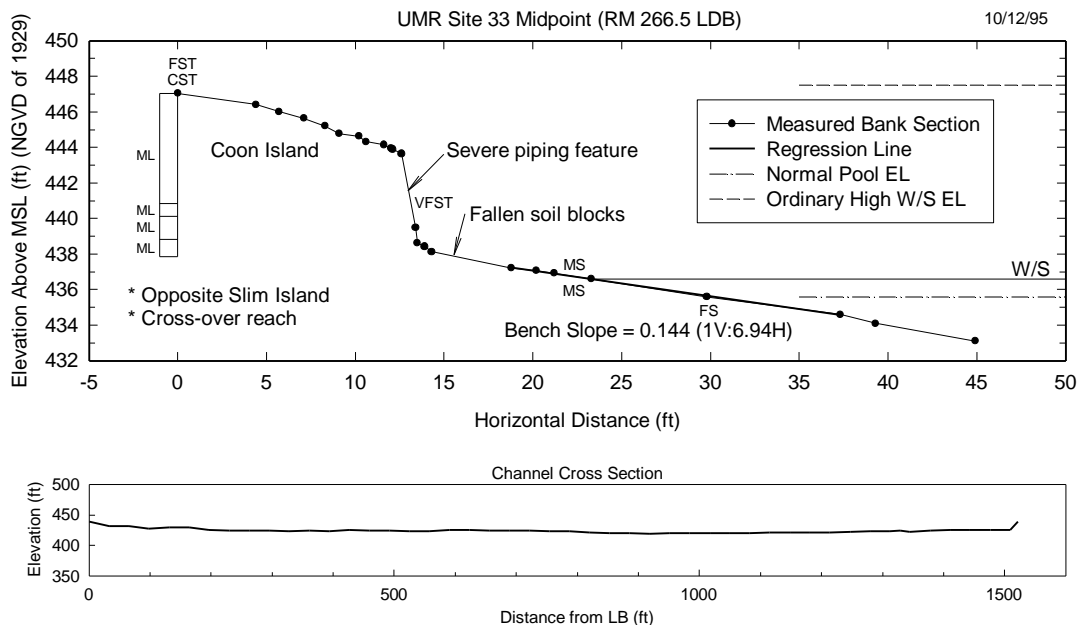
Figure 7-111 Bank section and channel cross section measured at Site 33 midpoint

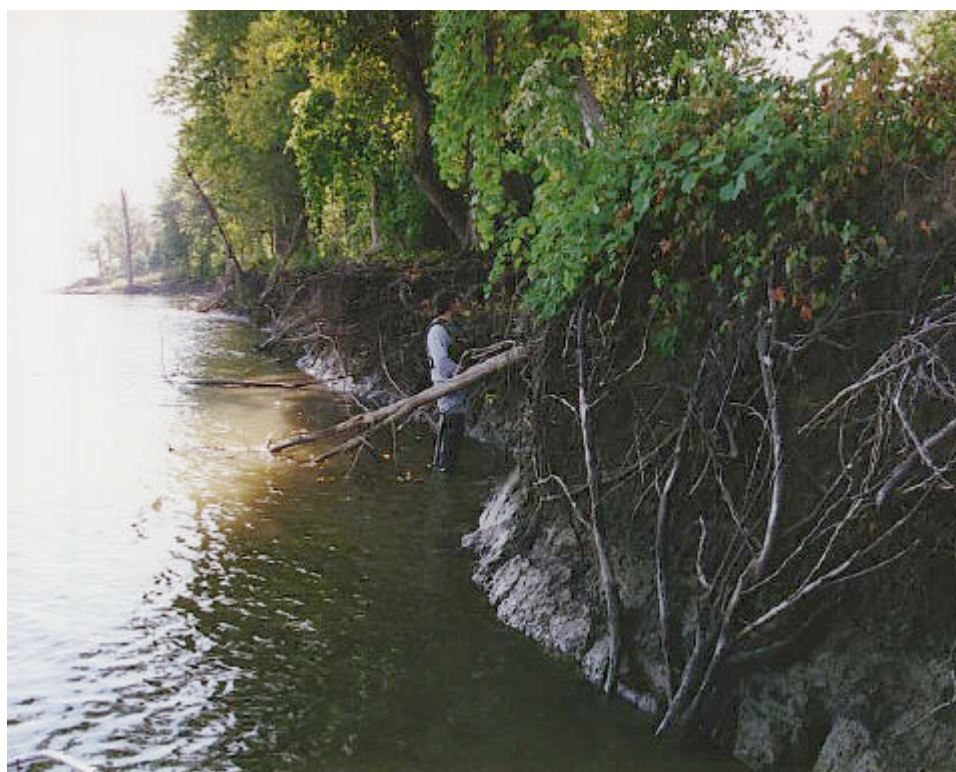
with minor piping, about 8 ft high, indicates that erosional oversteepening and collapse occurred during the Great Flood of '93 and the floods of

Photo 7-84 A downstream view of Site 34 midpoint

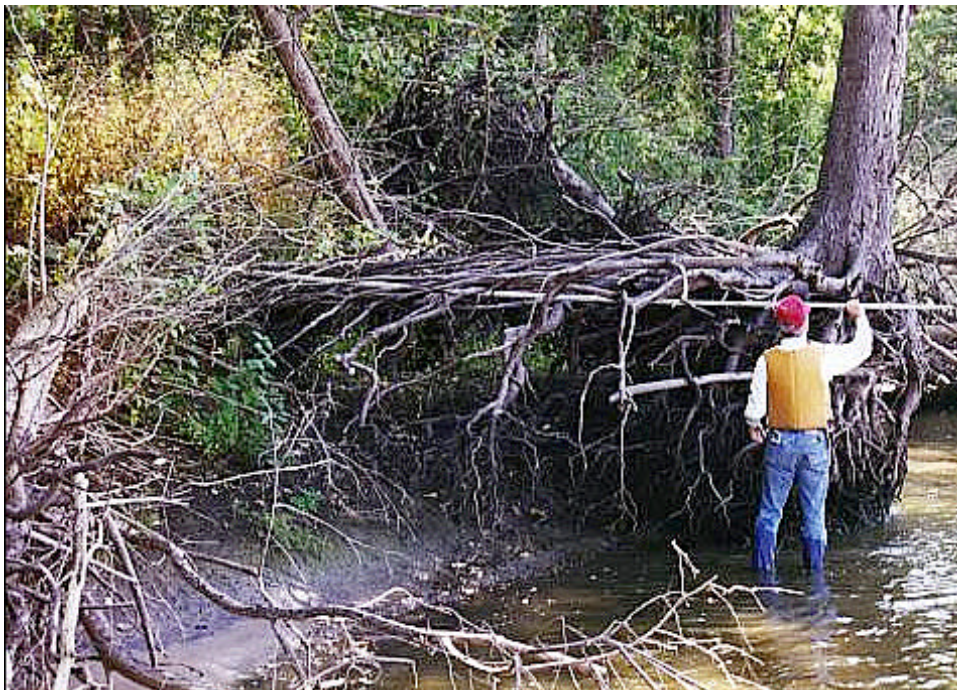
Photo 7-86 Inspection of tree roots at Site 35 midpoint
